REPORT NO. NADC-80177-30

AN/AMT-22 METEOROLOGICAL  
DROPSonde DEVELOPMENT

FINAL TECHNICAL REPORT

JMR Systems Corporation  
5 Tinkham Avenue  
Derry, NH 03038

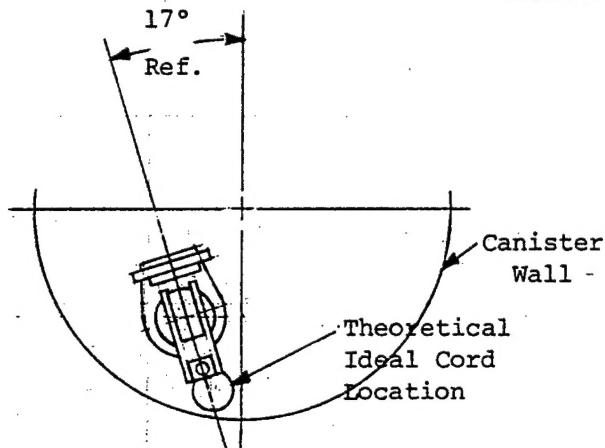
**ORIGINALLY PROPOSED DESIGN**  
(per Dwgs. Supplied)

(1) The profile of the lanyard pin release cam had originally ridden against the spring loaded moisture cover of the phone jack. It was found that the spring prevented smooth removal of the lanyard pin, thus forcing the cam, at times, to have an uneven contact with the cover and the lanyard pin to be "pushed" by the cover when the former is partially removed. (see Diagram 1). Also, to prevent the possibility of any excess lanyard cord material (beyond where the knot secured the cord to the release cam) either dislodging the cam from its position, or otherwise fouling the release action; because of the insertion of the main chute assembly, the knot may be eliminated and the cord heat sealed (mushrooming the end) at assembly to attach the cord to the cam. Since no parts had to be changed to implement this revision, it was incorporated into the 100 units.

Disadvantages: (1) Uneven cocking of lanyard pin during removal due to action of spring loaded jack cover on shaft connecting pin to cam  
 (2) Possible pinch of bag/chute against canister wall.

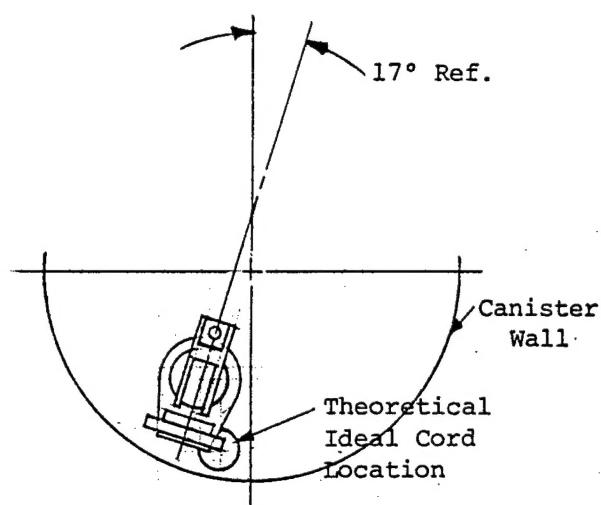
**100 DELIVERED UNITS**

Disadvantages: (1) Poor cord location.  
 (2) Uneven cocking of lanyard pin during removal due to action of spring loaded jack cover on shaft connecting pin to cam.

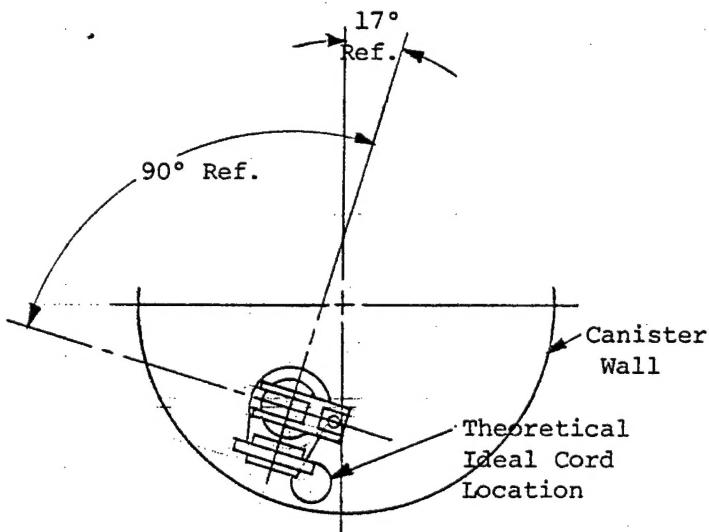
**RECOMMENDED DESIGN**

Advantages: (1) Good cord location

(2) Eliminates possible pinch of bag chute against canister wall.

(3) Prevents uneven cocking of lanyard pin during removal due to action of spring loaded jack cover on shaft connecting pin to cam.

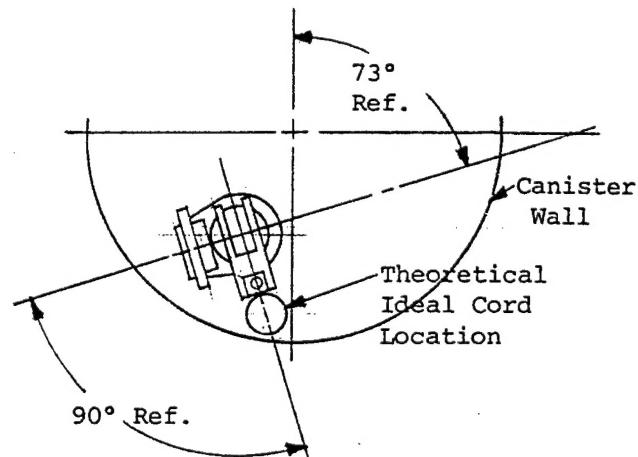
**PROPOSED DESIGN**  
(New Assemblies)

(1) Best cord location

(2) Eliminates possible pinch of bag chute against canister wall.

(3) Prevents uneven cocking of lanyard pin during removal due to action of spring loaded jack cover on shaft connecting pin to cam.
